Ak-Beshim (Suyab) 2018

Research Institute of Cultural Properties, Teikyo University
The Institute of History and Cultural Heritage,
National Academy of Sciences of the Kyrgyz Republic

Japan-Kyrgyz Joint Archaeological Expedition Reports Volume 2
Ak-Beshim (Suyab) 2018

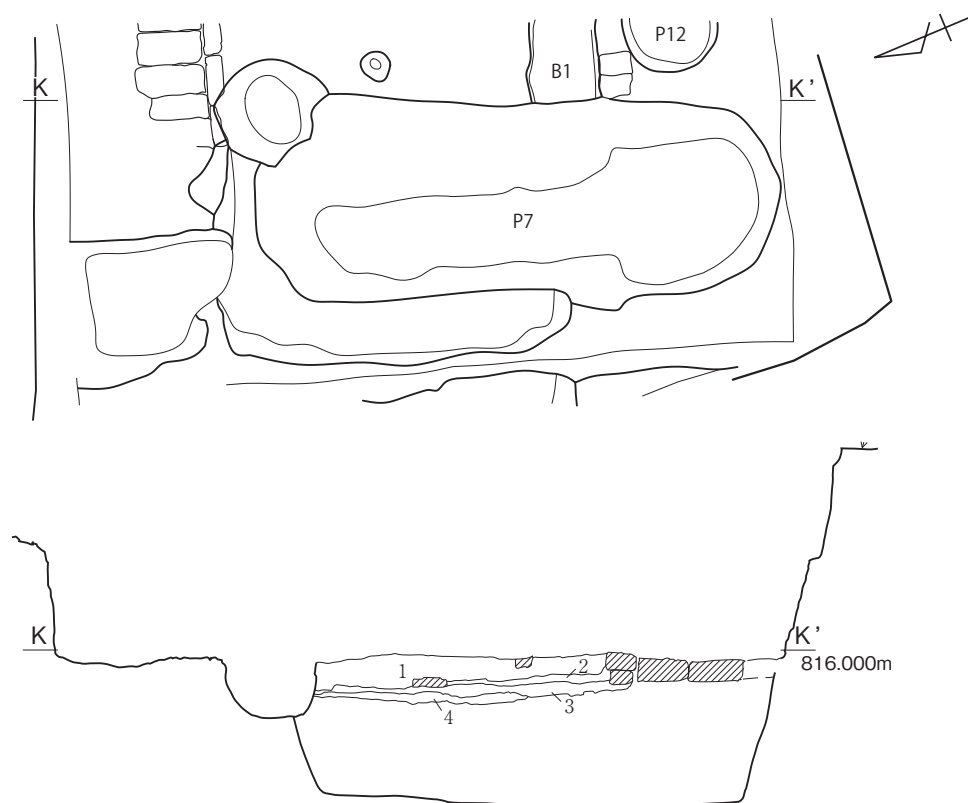
R3 P7

- 1 Dull yellowish brown soil + white particles: Dense, very compact. Contains charred particles.
- 2 Brownish gray soil: Dense, very compact. Contains charcoal (fine) (lightly black throughout).
- 3 Brown soil + white particles: Less compact. Large amount of charcoal, burnt particles, white particles (plaster).
- 4 Dull yellowish brown soil + charred particles: Fairly large amount of charcoal, charred particles.

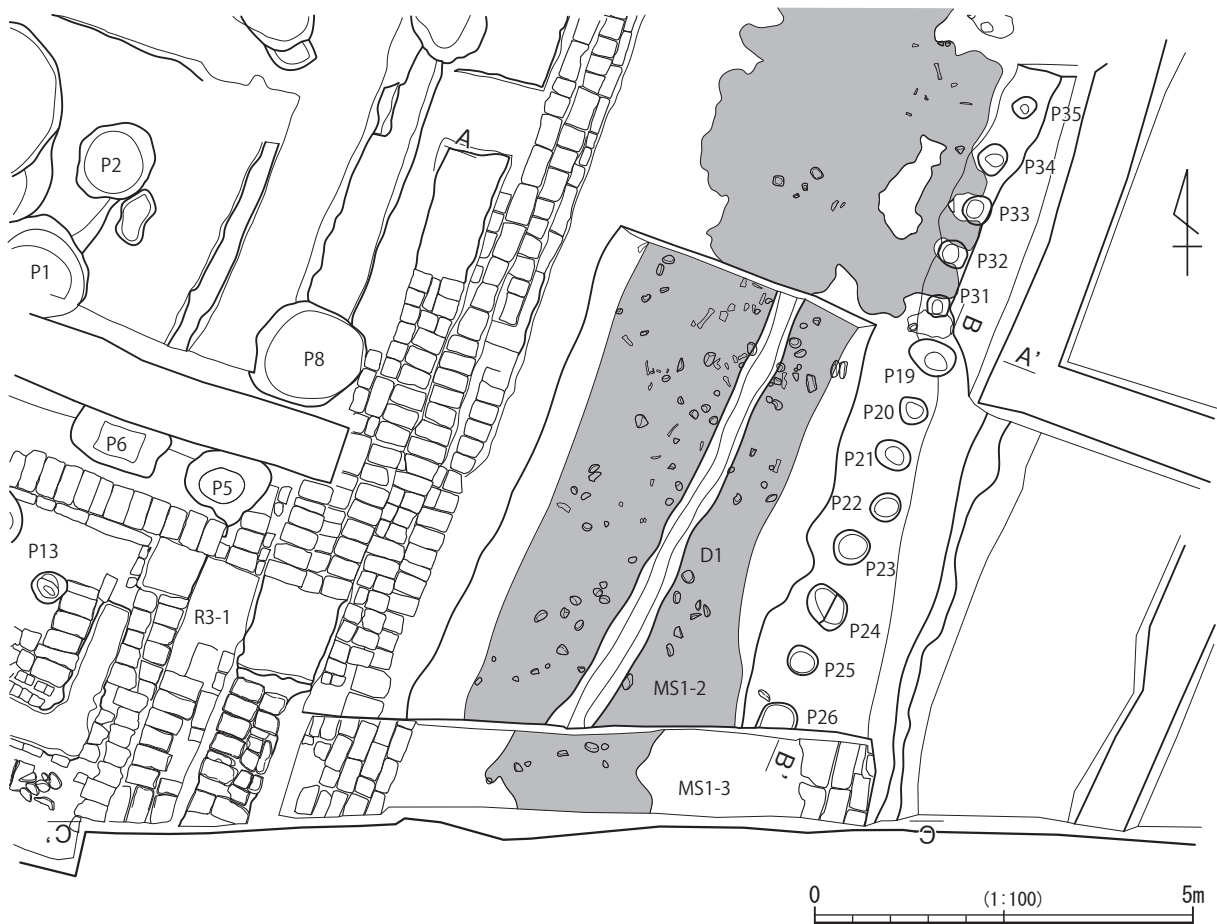
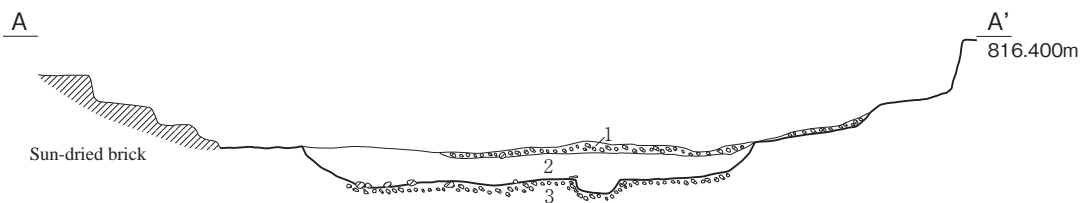
Fig.3.8 AKB-13 MS1

- 1 Iron slag pavement: Contains gravel, earthenware, bone.
- 2 Brown soil: Loose.
- 3 Gravel pavement: Top surface of MS1-2. Scattered earthenware, bones, etc.

- P19
 - 1 Dark brown soil: Loose. Contains large amount of gravel of Φ 2-3cm, fragments of earthenware, bone.
- P20
 - 1 Dark brown soil: Less compact. Contains large amount of gravel, fragments of earthenware.
- P21
 - 1 Dark brown soil: Moderately compact. Contains small amount of gravel of Φ 1-2cm.
 - 2 Brownish black soil: Moderately compact. Contains very small amount of charcoal of about Φ 5mm.
- P22
 - 1 Brownish black soil: Moderately compact.

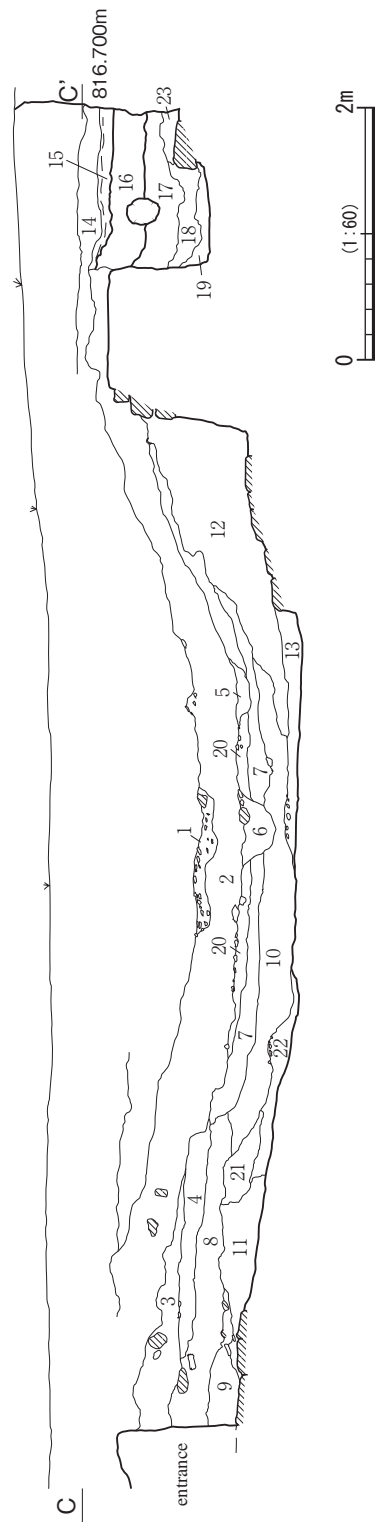
Fig.3.9 AKB-13 cross-section of MS1

- 1 Dull yellowish brown soil: Large amount of iron slag.
- 2 Dull yellowish brown soil: Contains gravel, charcoal, bone.
- 3 Dull yellowish brown soil: Loose. Contains earthenware, gravel, charcoal, white particles, burnt soil.

- 4 Orange soil: Very compact. Large amount of charcoal, white particles.
- 5 Brownish gray sandy soil: Loose. Mainly sand.
- 6 Dull yellowish brown soil: Less compact. Contains small gravel. Ditch in the center of the road surface. Fill.

In the investigation in 2017, the sub-trench established at the south wall of the excavation area revealed that older road surface existed below the slag paved road surface. This year, the sub-trench was therefore extended in the direction of the western wall in order to dig down lower layers and to explore the transition of the road surface and the temporal relation between the building foundation and the road surface. As a result, the existence of three road surfaces were revealed. They were named MS1-1, MS1-2, MS1-3 from the top. By observation of the cross-section of the road surface, the correspondence between the floor surface accumulation of three building features that had been confirmed in R3 and MS1-1 to 3 were estimated. It is possible that the construction and renovation of buildings were carried out at the same time as the formation of the road surfaces. This presumption is interesting in considering the formation process of the city.

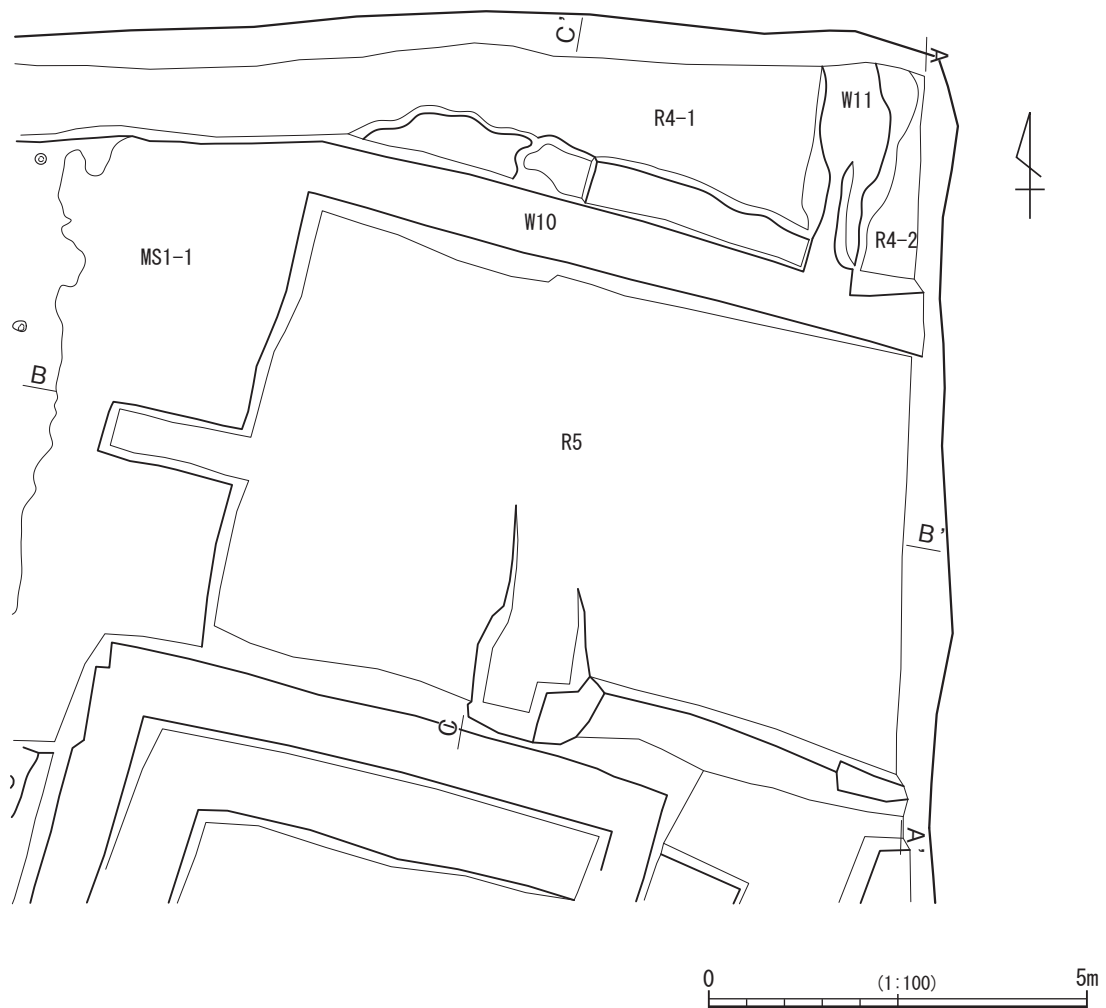
Fig.3.10 AKB-13 R4, R5

| 1 Dull brown soil: Loose. | 16 Dull yellowish brown soil: Fairly compact. |
| 2 Grayish yellow brown soil: Loose. Contains charcoal, burnt soil. | 17 Dark grayish yellow soil: Fairly compact. Contains charcoal in stripes. |
| 15 Grayish olive soil: Loose. Contains charcoal. | 30 Dull reddish brown soil: Top surface is road-shaped feature and forms the hard surface of road-like feature. |

hardened near MS1, it is not flat and rises towards the wall. Therefore, it is difficult to regard it as a residential facility. However, because three earthenware were excavated near W10 as if though they were installed and were accompanied by layers of burnt soil and charcoal, there may have been a kitchen stove by the wall. On the south side, near W7, a sufa 5m long, 0.8m wide, and 0.4m high exists just in the east side. Therefore, there is a possibility that it is a room structure, but there is no feature such as a pit in this area, and the situation is different from that of the room structures on the west side of MS1. Moreover, it is hard to regard this as a residential facility, considering that there is no wall to separate the area and the space is large. It is assumed that the floor surface of R5 corresponds to MS1-2 or MS1-3 because it is one step lower than MS1-1 surface. Four charcoals which had been collected from inside the soil layers of east-west belt were radiocarbon dated. Although they were collected from different layers, all belonged to the estimated age and it seems that fill in R5 accumulated in a relatively short period of time.

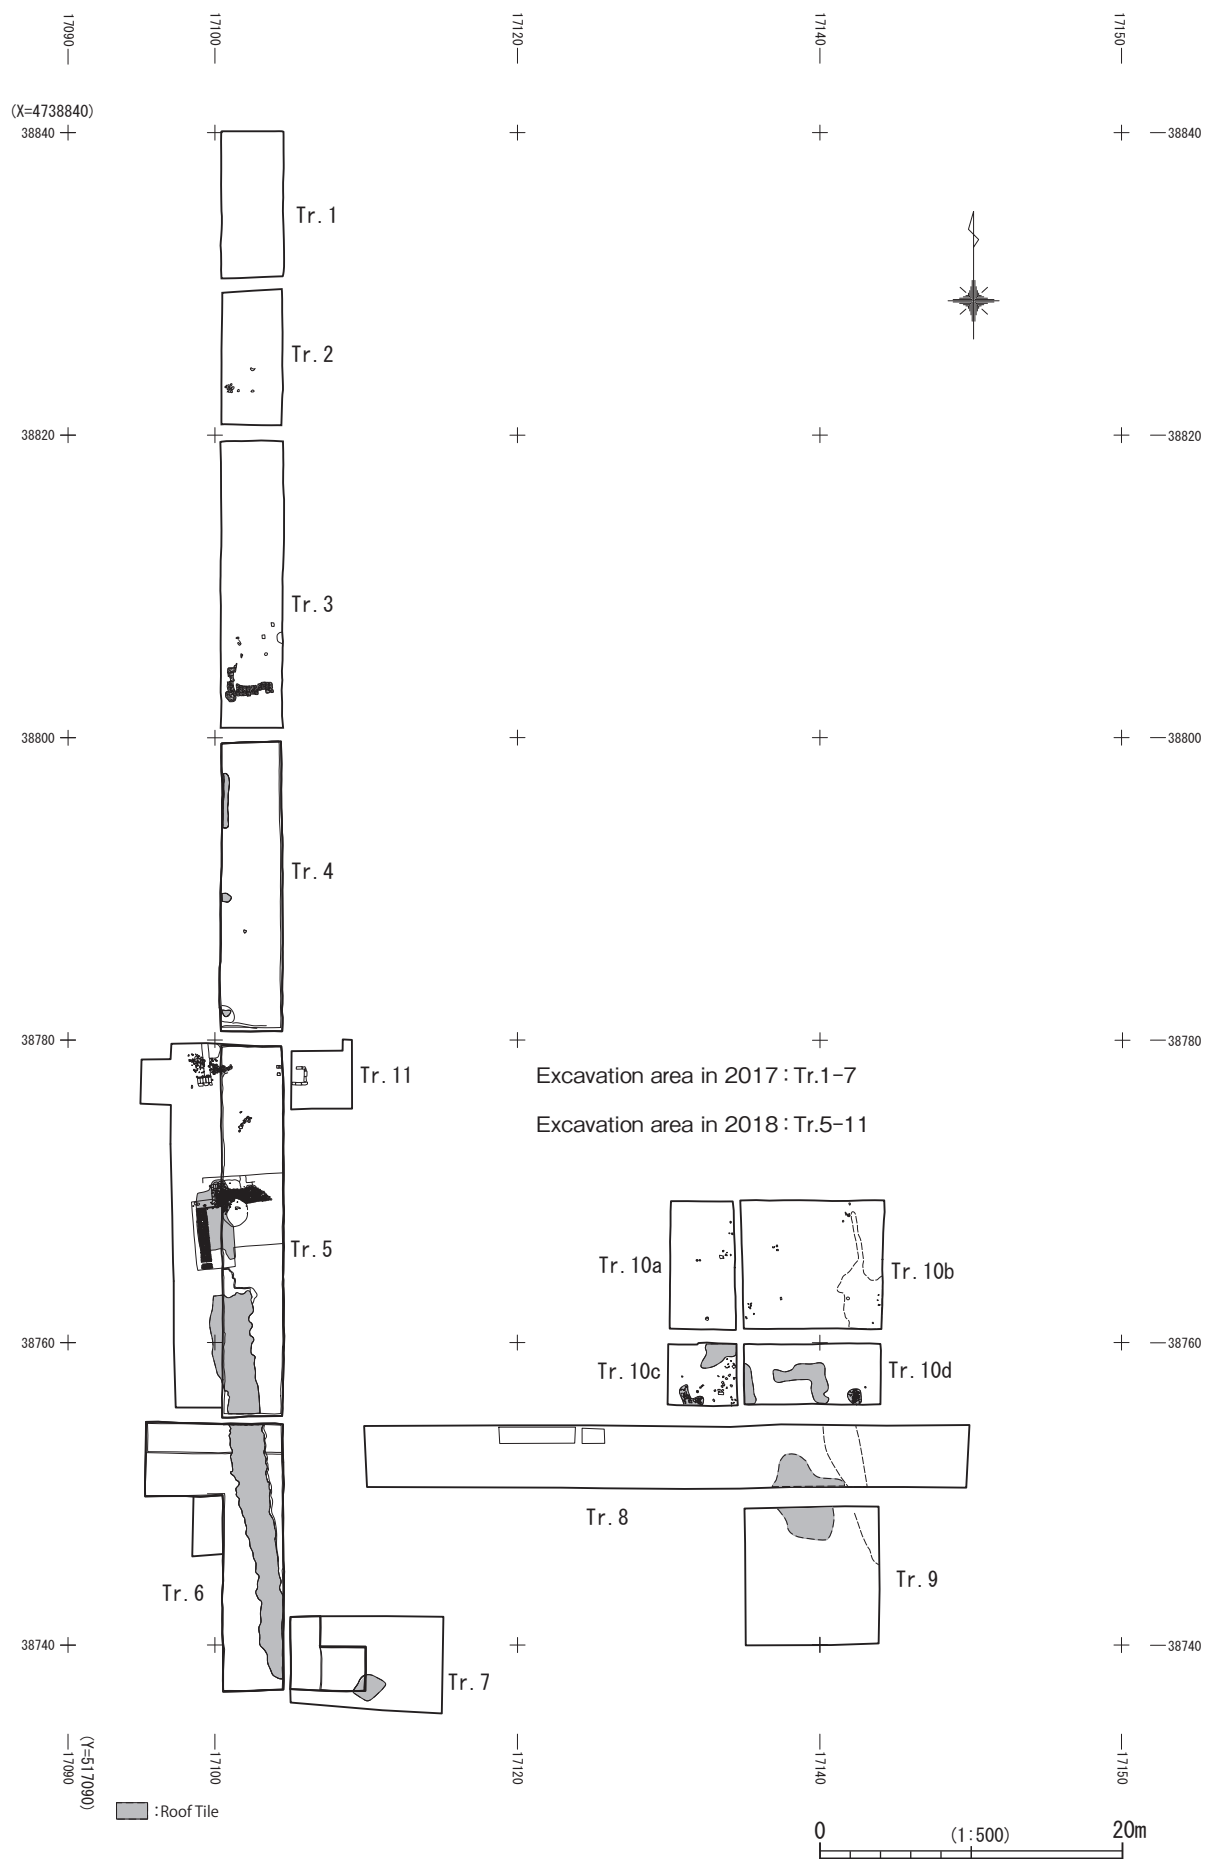
Fig.4.1 Full view of AKB-15

Tr.5 is a 25×4m trench in the north-south direction. Since the roof tile belt about 13 m in length was found in the trench in the fiscal year 2017, a trench of the same width and length was set up and widened on the west side of Tr. 5 to confirm the entire distribution of the roof tile belt. Additionally, when we dug down the lower layer of the northern end of the roof tile belt, a floral stone mosaic and a rain-permeable ditch made with greyish burnt brick were detected. The stone mosaic exists in an L shape, 4m east-west, and 4m north-south. It is placed on the outside edge of the rain-permeable

ditch. A 0.9-meter-long rain-permeable ditch was found near the north wall of the trench, and an accumulation of tile fragments was found on the north side of the trench. Therefore, building features with a width of 0.5m seem to have existed between two rain-permeable ditches in the north and south. Furthermore, the arrangement of the stone mosaic in conjunction with the rain-permeable ditch on the south side suggests that there was a courtyard or passage on the south side of the building, and that the outdoor decoration with floral stone mosaic was installed to surround the courtyard or passage. The stone mosaic in the north-south direction is separated by greyish burnt bricks in the middle. It was observed to extend further to the south, but the excavation had ceased in the middle. The stone mosaic in the east-west direction was cut and interrupted by well-like pits and disturbance-like pit (garbage pit), and gravels used for stone mosaic was excavated from the upper layer of the pits. The design pattern of the stone mosaic and the types and proportions of gravels will be described later. Reddish brown, blue (green), and white round gravel which can be collected from the surface of alluvial fan where the site is located was used to create the floral motifs. The colors become more vivid when wet. It was located beside the rain-permeable ditch and is thought to have had the effect of making a gorgeous atmosphere.

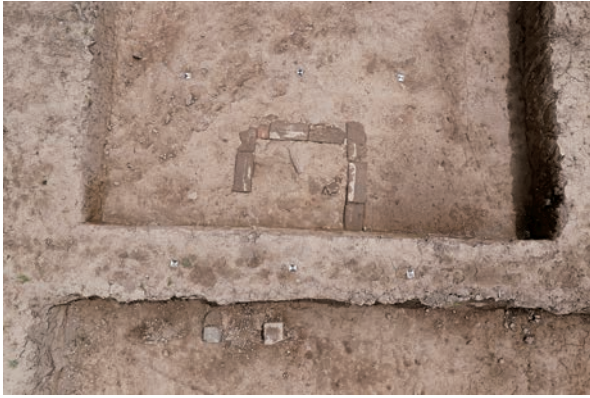
Fig.4.15 Rectangular section with the diversion of greyish burnt bricks in Tr.11

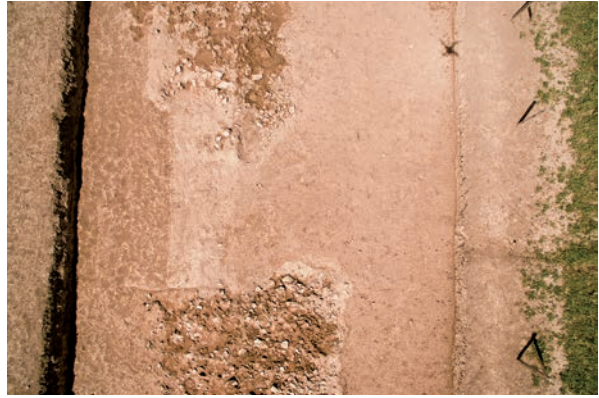
Fig.4.16 Roof tile belt after expansion of Tr.5

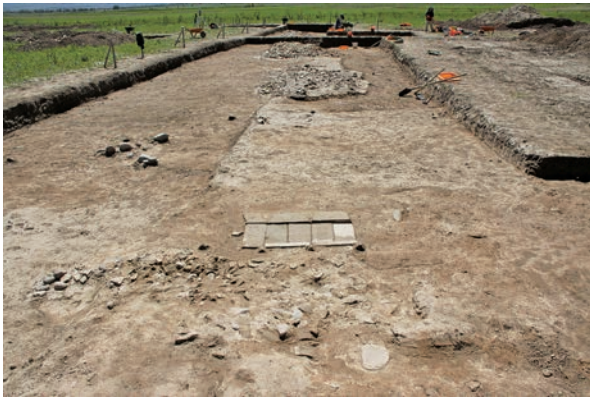
Fig.4.17 Platform-shaped feature and rain-permeable ditch made of greyish burnt brick in Tr.5 (from north)

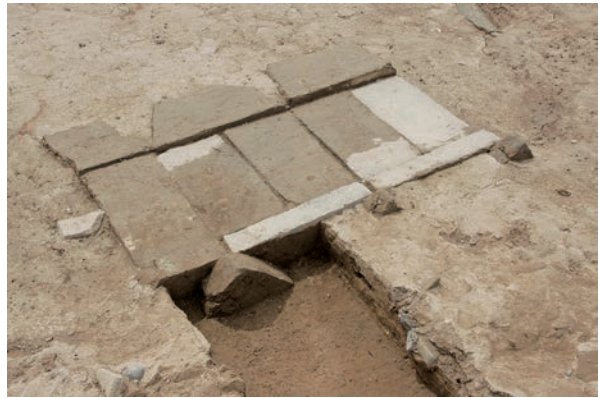
Fig.4.18 Rain-permeable ditch made of greyish burnt brick (from north)

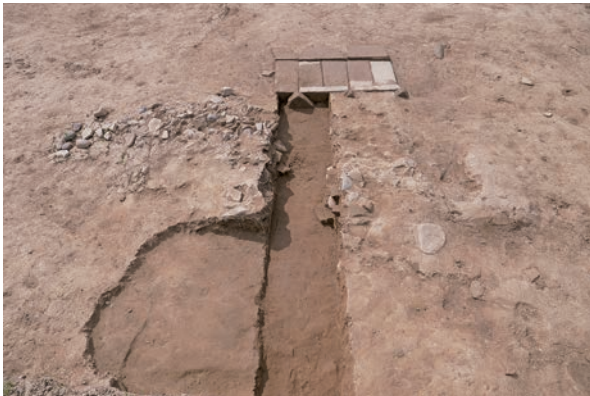
Fig.4.19 Rain-permeable ditch in Tr.5 during excavation (from north)
